PB91-916501
NTSB/PAR-91/01

PIPELINE ACCIDENT REPORT

LIQUID PROPANE PIPELINE RUPTURE AND FIRE
TEXAS EASTERN PRODUCTS PIPELINE COMPANY
NORTH BLENHEIM, NEW YORK
MARCH 13, 1990

ADOPTED: JUNE 11, 1991

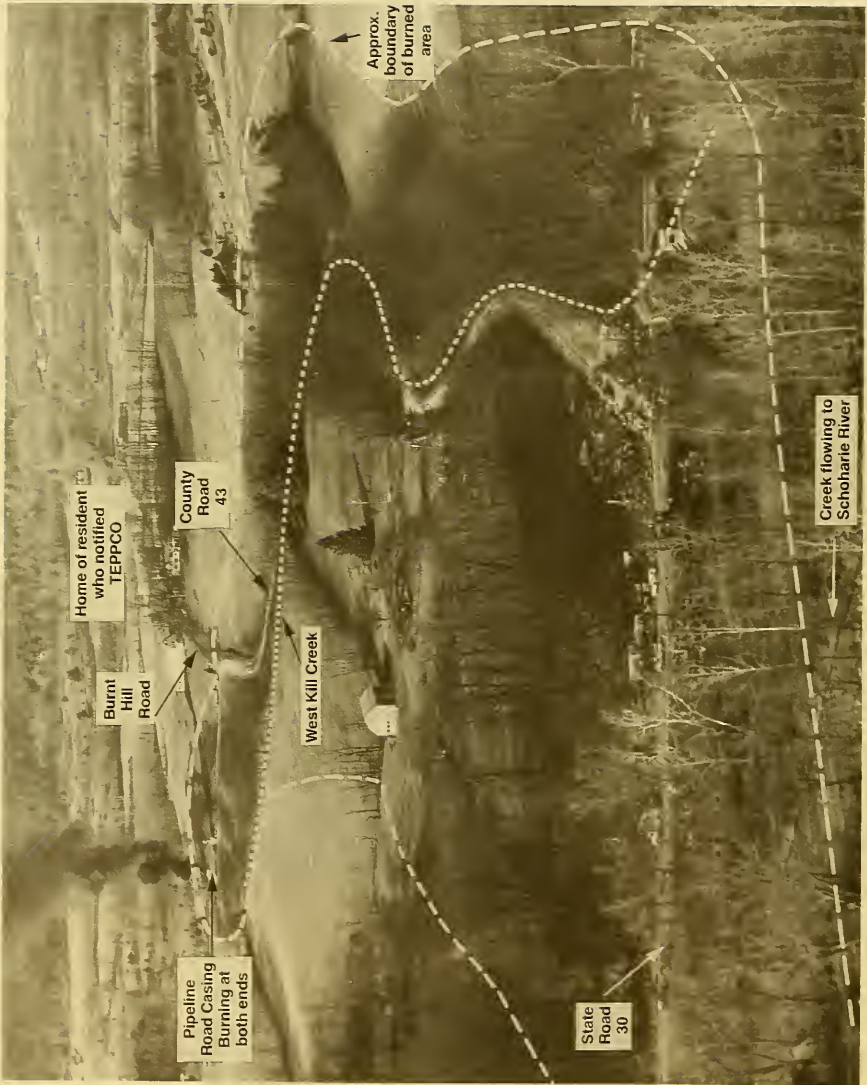
Figure 1.--Aerial view of the accident area.

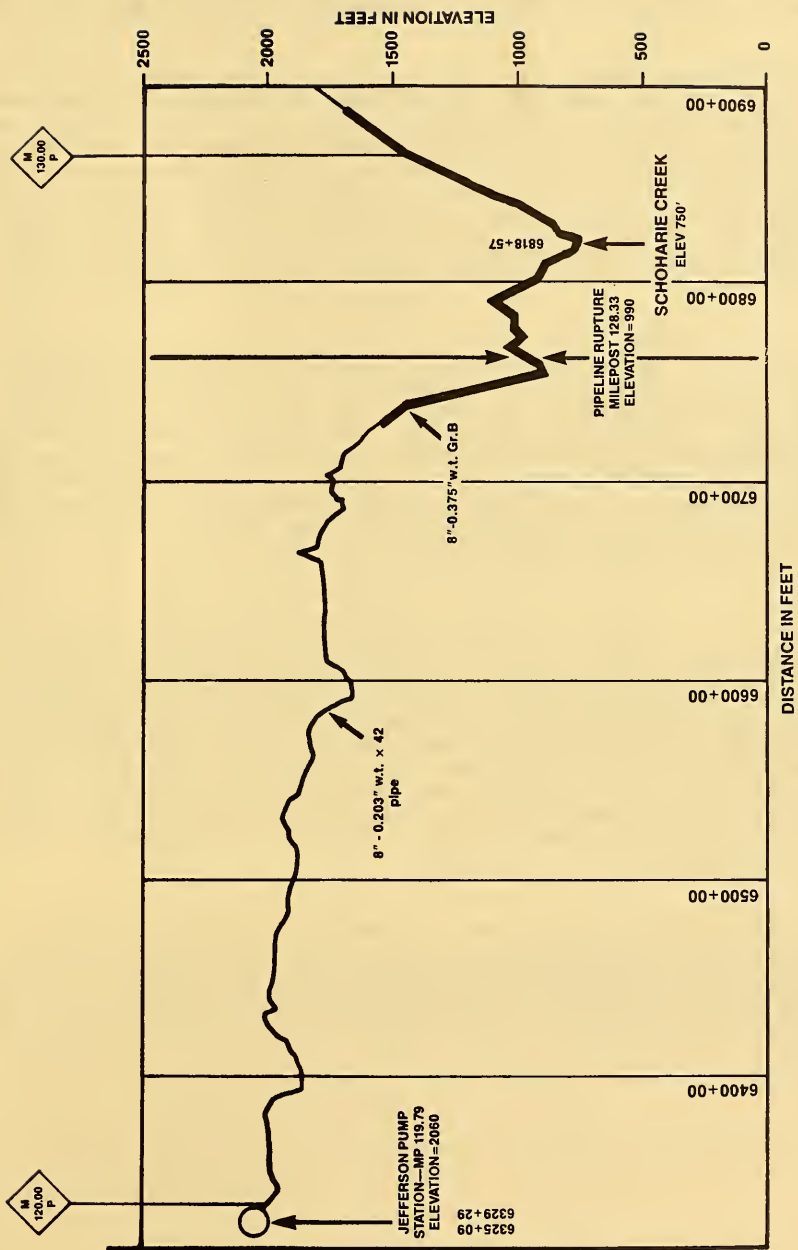
Figure 3.--Pipeline profile showing the location of the rupture.

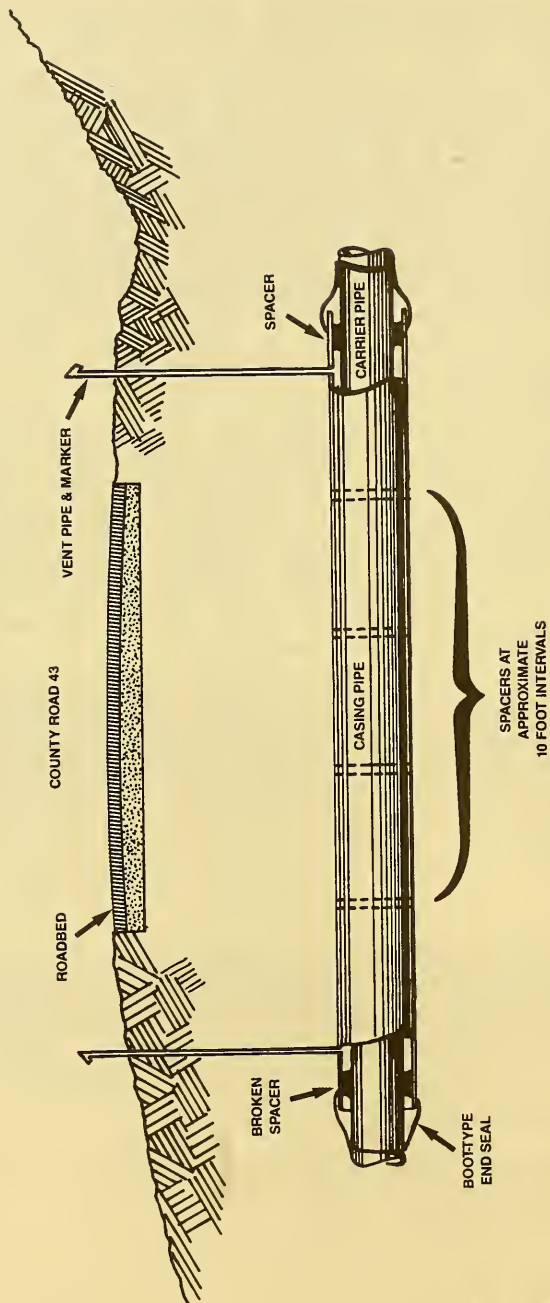
Figure 4.--Cross sections sketch of pipe crossing CR 43, Looking North.

On the east side of CR 43, an approximate eight-degree bend upward had been made in the pipe as it exited the casing, about 8 feet of soil covered the casing, and the earth cover over the pipe 30 feet east of the casing was about 6 feet deep. The ground on the east side was higher than the road, and it sloped down to the road at an approximate 14-degree angle. The pipe was found centered within the casing, and a casing insulator was near the end of the casing. A synthetic rubber end seal had not been damaged by the fire, but it had been moved 2 to 3 inches from the casing; its stainless steel straps appeared in sufficiently tightened to hold the seal in place.

On the west side of CR 43, the casing was about a foot lower than on the east side, making the slope of the casing about one degree downward to the west. The ground west of the casing was lower than the road, and it sloped

downward at a four-degree angle. The pipe had no bends as it exited the casing and was buried about 6 feet below the surface. It exited the casing to the west at a downward angle about $3\frac{1}{2}$ degrees relative to the casing. (See figure 6.) Other than fire and rupture damage, no other damage was visible. At the point where the pipe exited the casing, it was in contact with the bottom of the casing. The link seal, installed in February, was found about 3 feet from the end of the casing, and one of the links was broken. No evidence was present of select backfill (such as sand), sand bags, or other support for the carrier pipe except for the single, wooden skid that had been installed on February 21, 1990.

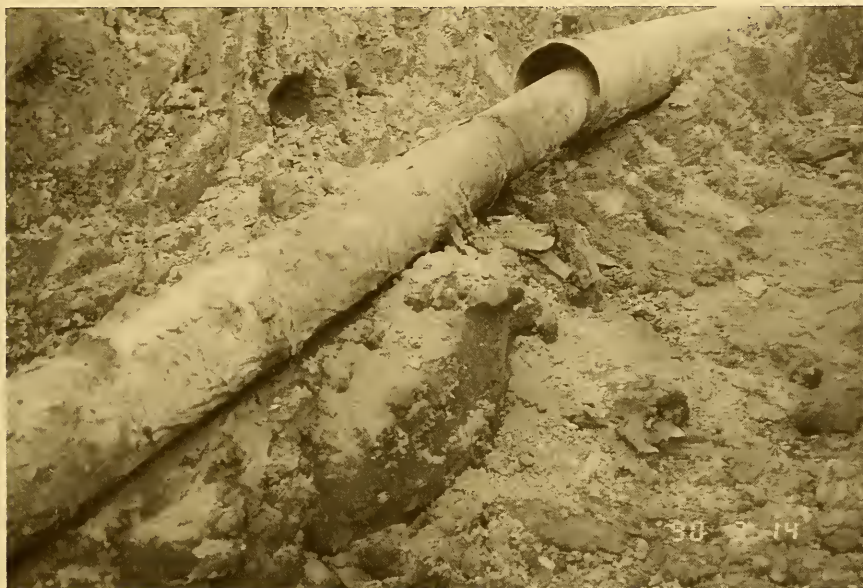
Figure 6.--View of the excavated pipeline showing its position relative to the casing at the west end.

The casing was cut longitudinally with a cutting torch, and the top section removed to reveal the pipe. A circumferential pipe fracture was found about 2 feet inside the west end of the casing and was 2 inches east of a pipe girth weld. The two fracture faces were found separated about 3/4 inch. Visual examination identified chevron marks on both fracture faces, indicating that the fracture was brittle and had initiated near the ERW longitudinal seam. When looking west, the longitudinal ERW seam weld was at the 11 o'clock position on the section of pipe that included the rupture. Five plastic casing insulators were installed on the pipe. The first at the west end was 13 feet 9 inches from the casing end, and the first at the east end was about 1 foot from the casing end.

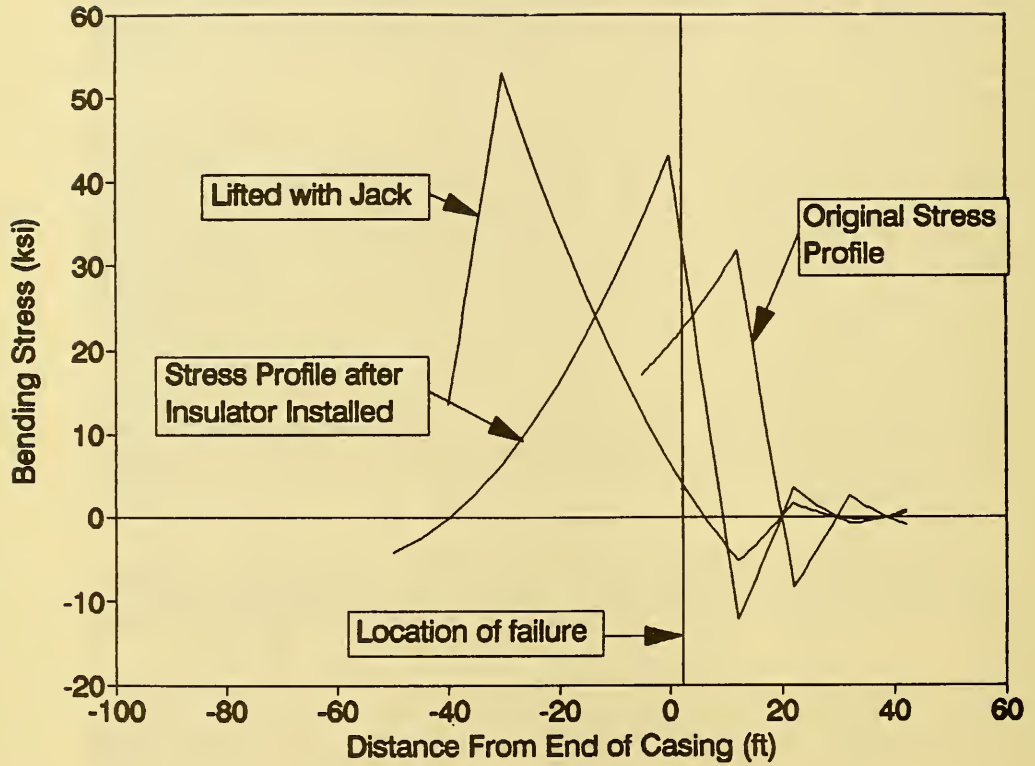
Stress Analysis.--Battelle performed a series of two-dimensional finite-element analyses to estimate the magnitude of the bending stresses in the pipe before, during, and after the repair work. Assumptions had to be made about the original pipe's raised positions and soil conditions. The analyses considered only bending stress. The calculations did not take into account any values for residual stress or axial stress from pressurization; these would have to be added. The analyses indicated that when the pipe was initially raised to remove the broken casing spacer, the maximum bending stress on the pipe increased from about 32,000 psi to about 53,000 psi. In addition, the point of the maximum stress moved from a few feet within the casing to about 30 feet west of the casing, where the jack lifted the pipe. After the link seal was installed in the annulus and the pipe lowered, the maximum bending stress was reduced to 43,000 psi at the end of the casing. At the point of failure, the bending stress was less than the maximum stress. (See figure 7.) The Battelle analyses indicated that the bending stress at the point of failure decreased from about 22,000 psi to 4,000 psi when the pipe was initially raised and increased to about 32,000 psi after the repair work. The net effect of the repair work performed on February 21, 1990,

Figure 7.--Battelle's bending stress profiles showing the stresses before, during, and after repair.

increased the bending stress by 45 percent at the point of failure. These analyses also considered the effect of settlement after the repair on the pipe, and with a settlement of 15 inches, the increase in the bending stress at the failure would have been about 10,000 psi.
